Customer story

Meeting the increasing demands of breast imaging

EPIQ ultrasound system

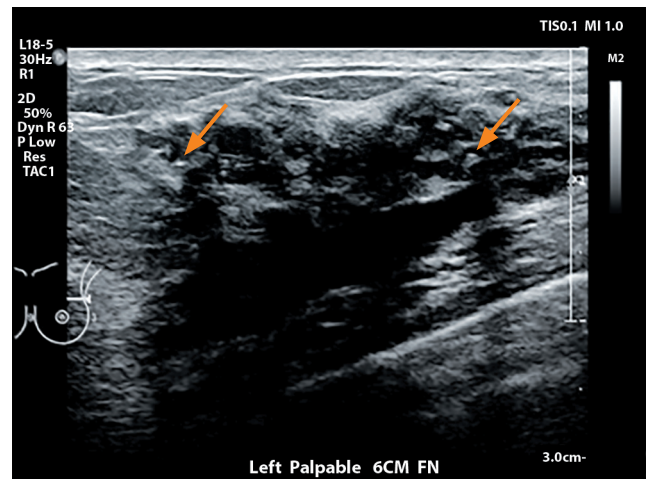
L18-5 imaging with TAC (tissue attenuation control) provides excellent visualization of echogenic foci (calcifications) within and outside (arrows) the breast masses, thereby allowing for core biopsy under ultrasound guidance.

In the area of mammographic and clinical concern, ultrasound showed two irregular hypoechoic masses with echogenic foci (calcifications) seen both within and outside the masses.

Dr. Bohm-Velez notes, “In the past, calcifications were only seen on ultrasound when they were within a mass. Therefore suspicious calcifications not within a mass required a stereotactic core biopsy. Now, in my experience with the EPIQ ultrasound system, we are starting to identify

calcifications even when they are not associated with a mass, therefore allowing us to biopsy them with ultrasound guidance. This quicker and less expensive approach reduces patient anxiety compared to the stereotactic technique.”

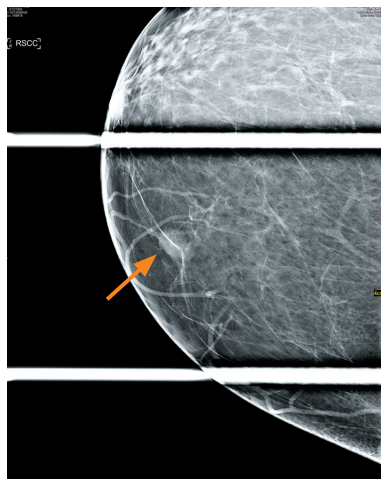
Spot compression in 90° projection shows a mass within the right breast.

A 53-year-old woman presents for a baseline mammogram, which shows a mass in the right breast at five o'clock, best seen in the spot compression views.

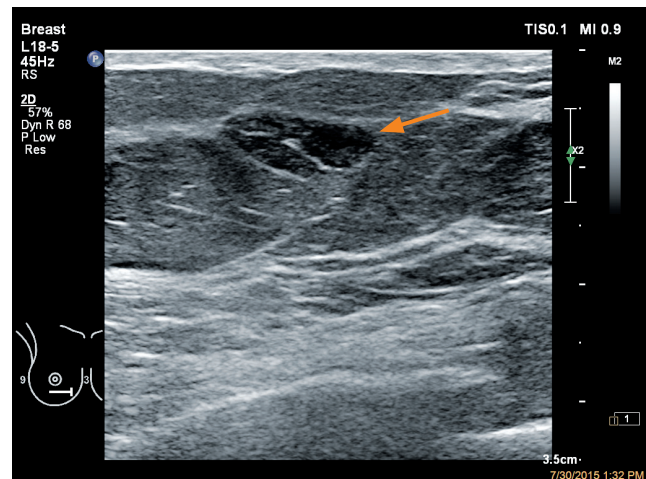
The excellent resolution of the EPIQ L18-5 transducer demonstrates a benign appearing mass not seen on a different ultrasound system. A BI-RADS 2 was assigned which obviated the need for a stereotactic biopsy procedure and the patient was recommended to return in a year.

Initial ultrasound imaging showed no abnormality in that area. Scanning with the EPIQ system showed a circumscribed oval benign-appearing mass corresponding to the mammographic finding.

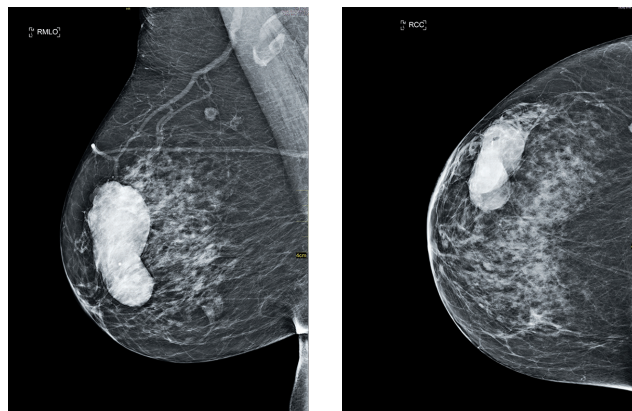
Right breast mammogram demonstrates a large lobulated mass within fatty tissue.

Mammography showed a 7.7 x 6.8 x 3.7 cm dense lobulated, circumscribed mass in the upper outer right breast corresponding to the palpable mass.

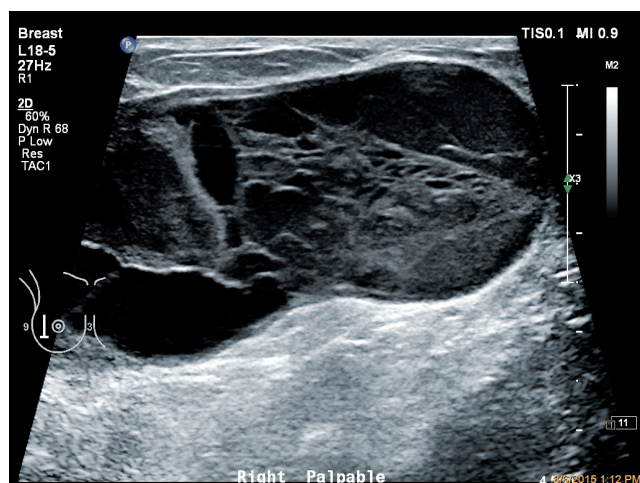
The L18-5 demonstrates excellent resolution of a debris-containing cyst corresponding to the palpable and mammographic mass.

Ultrasound of the upper outer quadrant of the right breast showed a large debris-containing cystic mass corresponding to the mammographic and palpable abnormality. Marked vascularity with color flow Doppler was identified in the periphery of the mass confirming a solid component, increasing our concern and therefore requiring an ultrasound-guided core biopsy to be done.

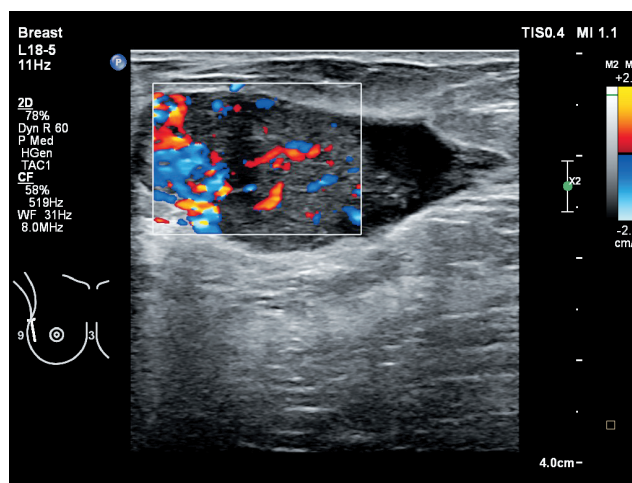
Color flow Doppler showed chaotic vascularity in the periphery of the mass, confirming a solid component, and raising suspicion, therefore changing the work-up of this patient to include ultrasound-guided core biopsy.

Ultrasound-guided core biopsy showed intracystic papillary carcinoma, which was confirmed by surgical excision.
